# Manhole Inspection Summary

Manhole # S29II\_018MH

**Location** Address: **1601 MCMECHEN ST**

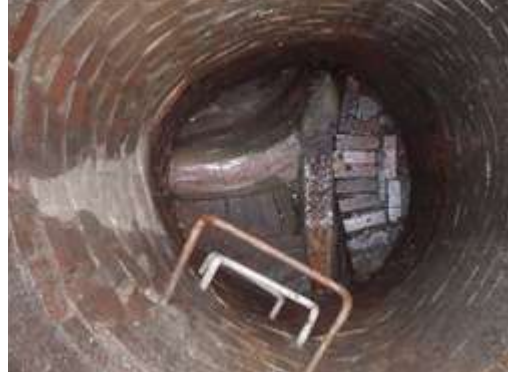
Top View

**Bench** ☒ Exists Material: **Brick** ☐ Parged ☒ **Debris** (not Condition related)

Bench debris.

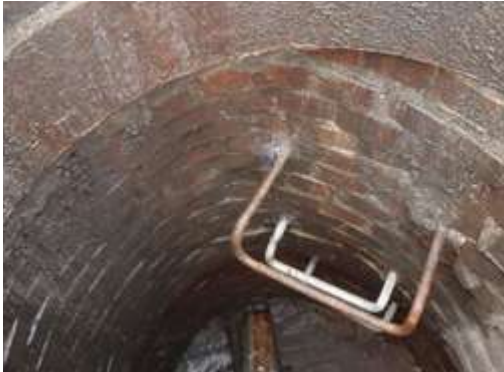
Defect

**Frame** Offset: **0.5** (in.) Condition: ☐ Sound ☐ Cracked ☒ **Leaks**

Infiltration: ☐ None ☒ **Joint** ☐ Cracks ☒ **Mortar** ☐ Roots ☐ Wall

Frame leaks. Adjustment infiltration - other side.

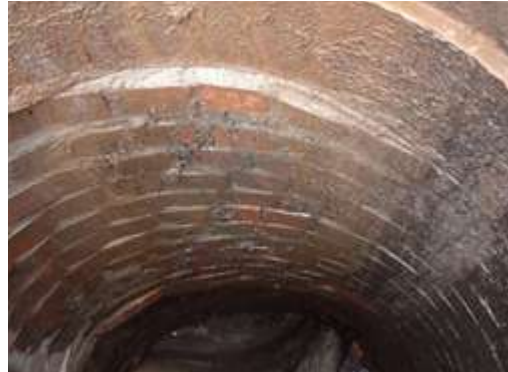
Defect

Frame leaks. Adjustment infiltration.

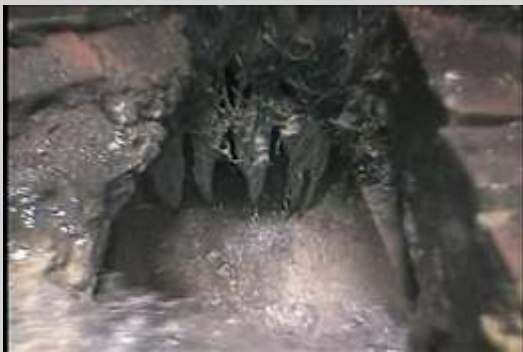
### 8 in. Circular Gravity Sewer Pipe Out @ 12 O'Clock

Condition: ☐ Sound ☐ Cracked ☒ **Root Intrusion** ☐ Loose Brick ☒ **Deteriorated**

Infiltration: ☐ None ☐ Joint ☐ Cracks ☒ **Mortar** ☒ **Roots** ☐ Wall

Barrel deterioration, root intrusion and infiltration.

Infiltration: **Evidence** Pipe Seal Cond: **Roots**

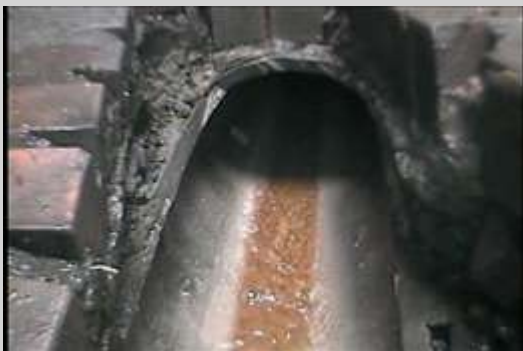
### 8 in. Circular Gravity Sewer Pipe In @ 6 O'Clock

Condition: ☐ Sound ☐ Cracked ☐ Root Intrusion ☒ **Deteriorated** ☐ Leaks ☐ Debris

Bench and Channel deterioration.
